Use of Hydrogen Peroxide and UV to Degrade GTC in VL/EID Liquid Waste, Uganda experience

Joel Peter Opio
Lab System Branch,
CDC-Uganda

July 2024

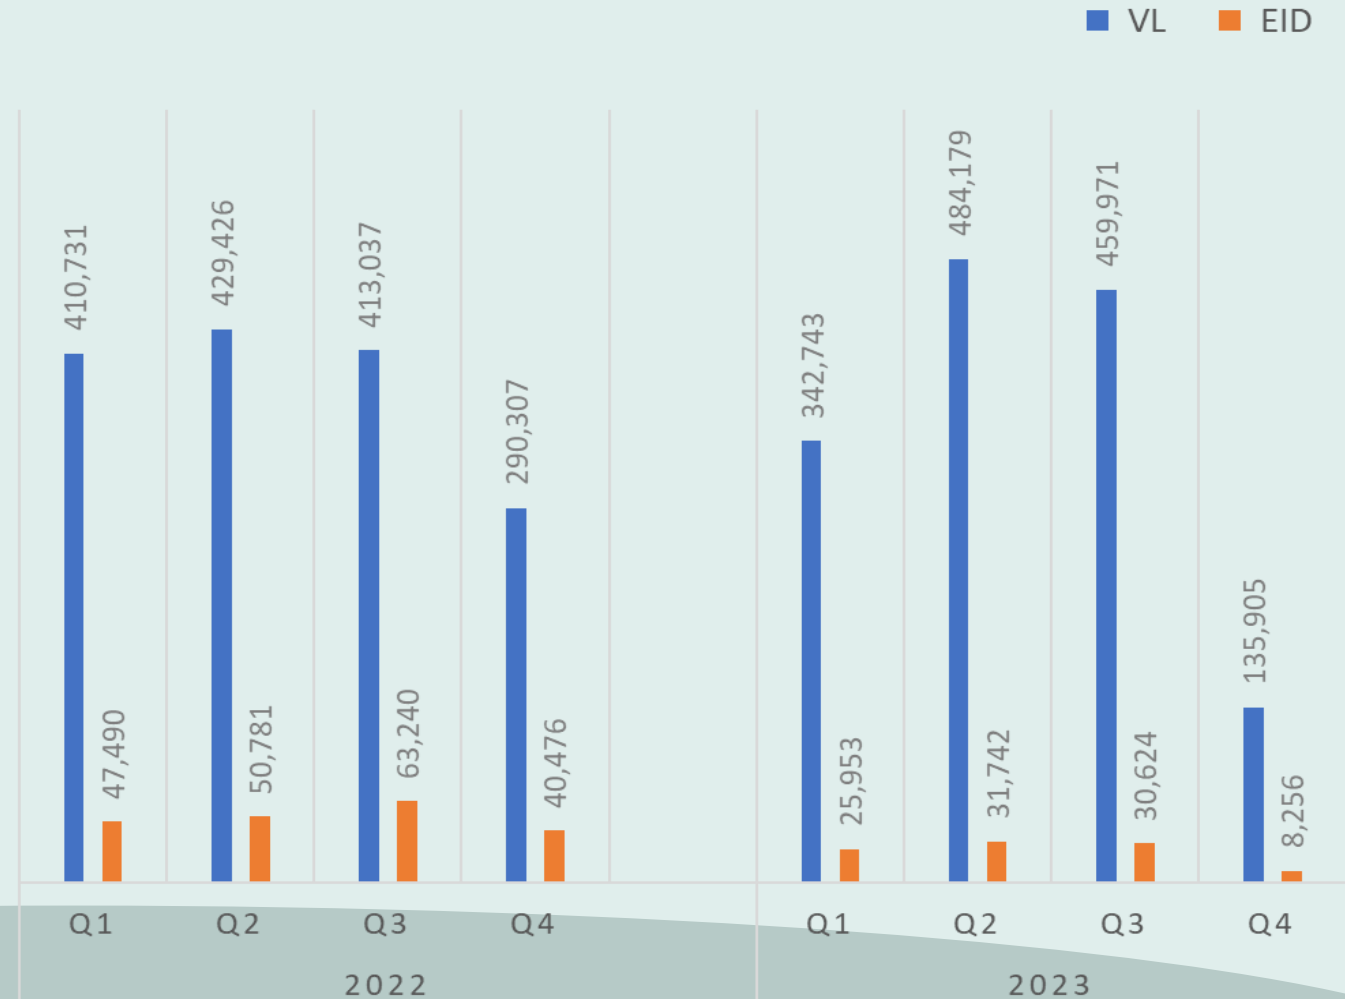
QUARTERLY VL AND EID LAB TEST OUTPUT 2022, 2023

Tests over **1.5 million** VL & EID tests annually

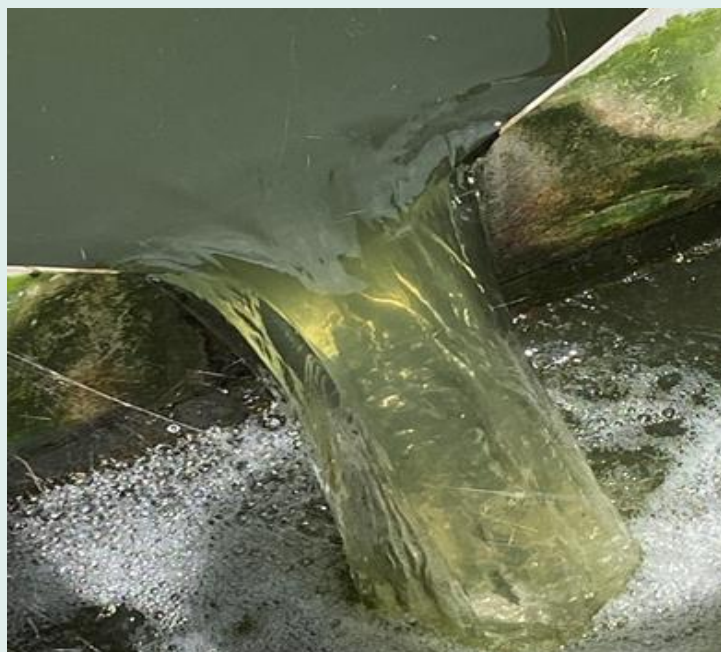
Liquid Waste

- About **100,000** total liters per month.
- **12,000** liters from VL/EID platforms/month

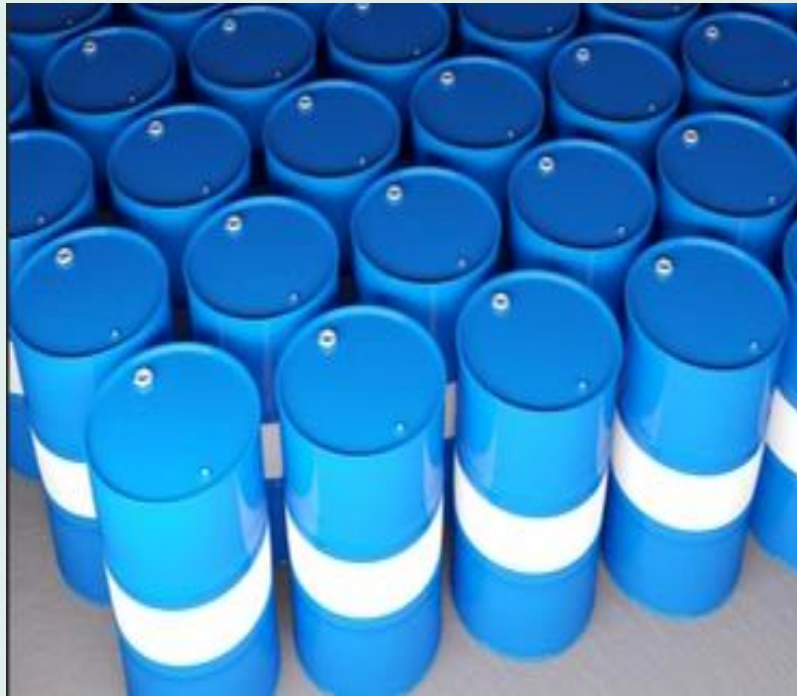
12,000 liters translates into about 120 drums of water to illustrate

- Ferried every 2 weeks by an external service provider at the cost of USD 2000 per collection.
- The service provider disposes the waste at the military facility.
- Final disposal site at the military facility is highly restricted thus unknown to the central lab
- Disposal such volumes can't be ignored

The liquid waste is stored in an underground containment tank

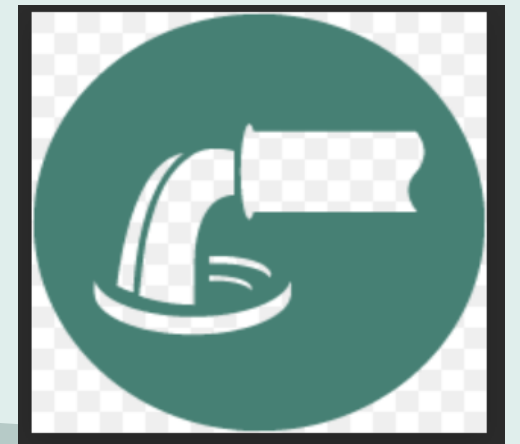
Justification

- The quantity of the liquid waste generated (400 liters **per day**), and risk of GTC as highlighted in the MSDS for VL/EID reagents required attention.
- Characterization **confirmed** presence of cyanide in the liquid waste and other stubborn materials (recalcitrant).
- The analysis of the samples was done in an accredited lab called **Set point**, South Africa.

- The initial tested conduct indicated presence of **total cyanide levels in the range of 400mg/l - 700mg/l.**
- This is way above the NEMA recommended maximum levels of 0.1 mg/l
- In addition, there was contamination due to minerals such as: chromium, selenium, manganese, Nickel and Titanium in micrograms, which can be a threat if bioaccumulated in the environment.

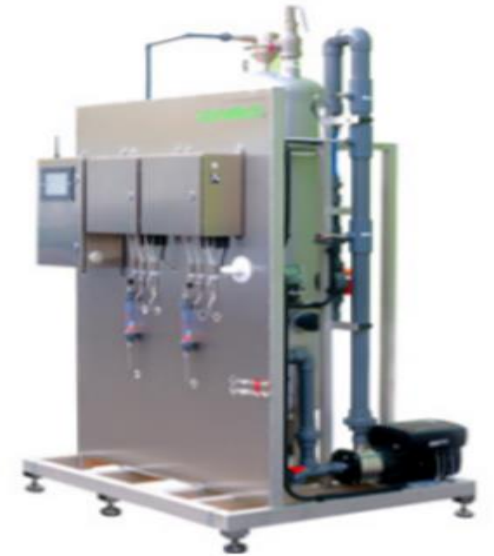
RENA Vivo C-series

- Involves a big and often complicated kit particularly in ozone generation.
- Require air compressors, air filters, cooling water, need for a lagoon

system designed to cover most needs in disinfection and treatment in versatile environments and industries such as large breweries, pharmaceutical production and process manufacturing.

The C-series is our highest capacity ozone system of the Vivo range, designed to solve complex treatment challenges such as break-down of pharmaceutical residues and complex substances. It is a perfect solution for ensuring large flows and volumes of high quality process water supply. It is delivered with an integrated oxygen generator or external oxygen supply.

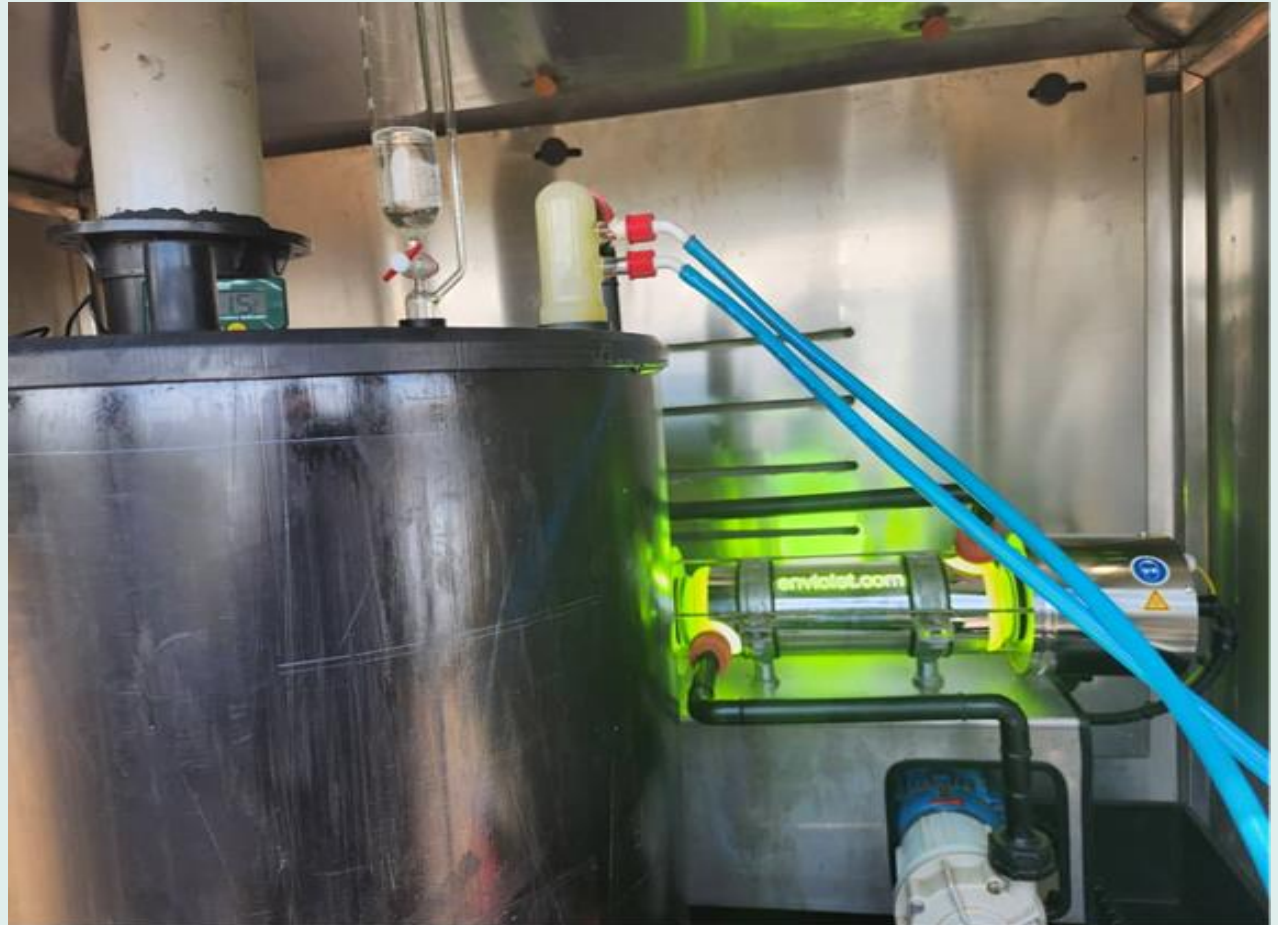
LabClean Machine (Enviolet™)

Hydrogen peroxide /UV

- Selected as the method of choice.
- The requirements for set up are less elaborate compared to the other methods.
- Can be accommodated in small space,

- GTC waste is treated with Hydrogen peroxide in presence of UV Light at ambient temperature and pH for a period of 1-2 hrs. The process is performed under a fume hood to exhaust any hazardous emissions that may have been released inadvertently.
- Checks are carried out to establish that cyanide is degraded to undetectable levels
